# TECHNICAL BULLETIN

**[Issue No.]** T09-0016-A

**[Title]** Causes of error code: F222H by the mistaken operation and relative countermeasures (Cautions for access to other station in the MELSECNET/H network systems)

**[Relevant Models]** QJ71LP21-25, QJ71LP21S-25, QJ71LP21G, QJ71LP21GE, QJ71BR11

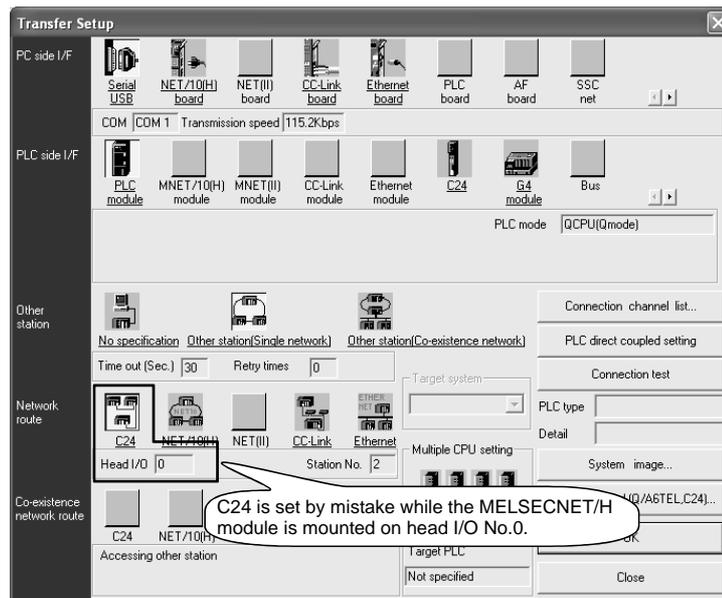
2) Incorrect setting (when select C24 for the network route)

If other station access is executed after the network route on the GX Developer Connection Setup screen is set to C24 or CC-Link by mistake, in the MELSECNET/H network system, the following phenomena may occur.

When a MELSECNET/H module receives the request message for C24 or CC-Link mistakenly by the operation above, the MELSECNET/H module transmits the request message to all stations. If the head I/O No. of the MELSECNET/H module corresponds to that of the station which transmitted the request message, the MELSECNET/H module transmits the request message to all stations, resulting in congestion at each station, and the phenomena 1) to 4) occur.

If the above situations occur, perform the following operation to restore the system.

- Power off all PLC CPUs in the network in which error code: F222H is occurred.  
(The PLC CPUs of all stations has to be powered off.)

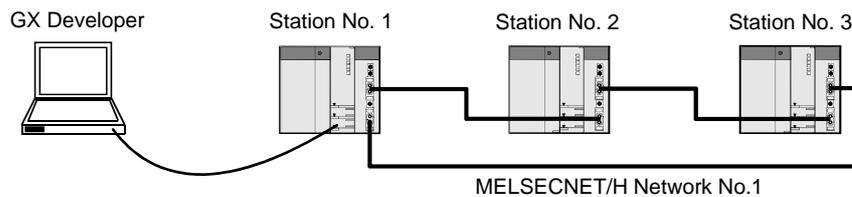
## 3. System configuration

- 1) The network route on the GX Developer Connection Setup screen is set to C24 or CC-Link by mistake.
- 2) The MELSECNET/H module is mounted on the head I/O No. of setting 1).
- 3) The other MELSECNET/H modules are mounted on the head I/O Nos. of the other stations in the same network.

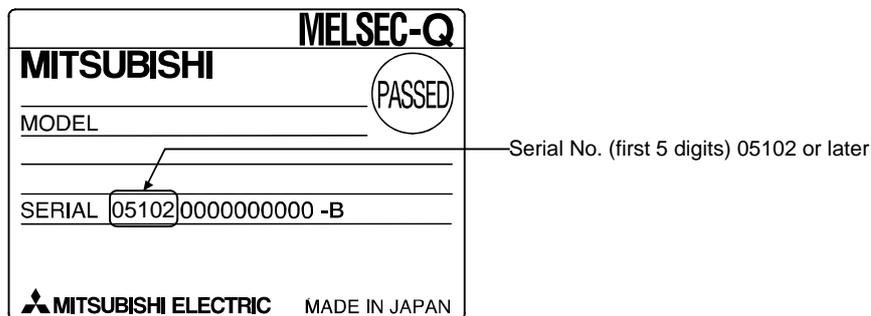
The MELSECNET/H module with the serial No. (first 5 digits) 05102 or later has been improved so that the error response is returned when the network route is mistakenly set.

The serial No. of MELSECNET/H module is located on the rating plate at the side of the module.
