TECHNICAL BULLETIN

[Issue No.] FA-A-0097-A

[Title] Troubleshooting for safety controller (MELSEC-WS series)

[Relevant Models] MELSEC-WS series

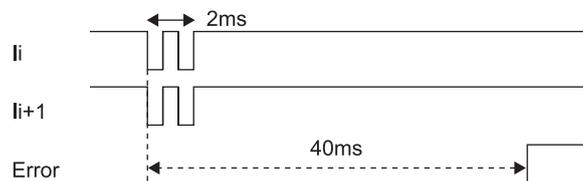
Figure 2: Behavior of unequal input data 1)

CPU	0x002AC006	Unequal input data from extension module n (*1)	<ol style="list-style-type: none"> 1) A dual channel input at XTIO module or XTDI module has 2 signals dips (high to low) with a time distance of 2ms (e.g. test gaps of a OSSD output, or bouncing relay contacts). 2) A signal channel input at XTIO module or XTDI module changes state in intervals of 4ms for a duration of 40ms or more (e.g. proximity switch to a tooth wheel). 	To reset the error, turn power supply of CPU module off and on. Activate the ON-OFF-filter and OFF-ON-filter. Please be aware that by this the response time for this signal is increased by at least 8ms.
CPU	0x002D4006	MELSEC-WS system performed a restart due to power supply dip at the CPU module.	<ol style="list-style-type: none"> 1) Power supply of CPU module had short voltage dip (to almost 0V). 2) Power supply of CPU module had a voltage drop (approx. down to 6V to 16V) and increased back to operating range. 	<ol style="list-style-type: none"> 1) Ensure that power supply is capable to buffer power interruption up to 20ms. 2) Ensure that power supply is capable to drive the load, so that switching of loads do not cause a drop of the supply voltage. 3) Check power supply wiring of CPU module. Use separate to other big loads, to avoid voltage drop on the supply cable by other load currents.

1) “A dual channel input has 2 single dips (high to low) with a time distance of 2ms”

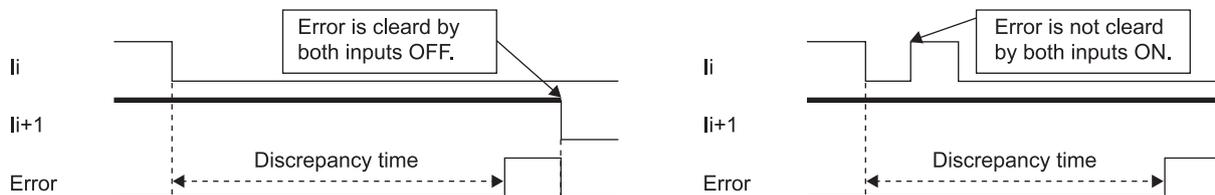
Figure 4: Behaviors of a discrepancy error

Module	Error Code	Message	Cause	Corrective Action
I/O	0x4429	Extension module n: Discrepancy time error at dual channel input Ii (*2)	<ol style="list-style-type: none"> 1) There are mechanical positions, where only one of both switches changes the state, without the other switch following within the configured discrepancy time. 2) Short circuit in the wiring of the dual channel inputs to another wire, e.g. 24V or 0V. 3) Hardware failure of switch, e.g. one of both contacts is permanently closed or opened. 	<p>To reset the error, turn off the effected switch (effected input states low/low for equivalent dual channel inputs, low/high for complementary dual channel inputs), or turn power supply of CPU module off and on.</p> <ol style="list-style-type: none"> 1) Check mechanical dependency of both switches. 2) Check wiring of effected inputs. 3) Please switch in hardware installation.
I/O	0x4601	Extension module n: Cross circuit at input Qi	<p>For inputs which are connected to test output:</p> <ol style="list-style-type: none"> 1) Short circuit to 24V or cross circuit in wiring for tested sensors. 2) Cable interruption in wiring for safety mat. 3) Defect testable sensor or safety mat 	<ol style="list-style-type: none"> 1) Check wiring of effected input. 2) Replace testable sensor. To reset the error turn off the effected input (input state Low/Low for equivalent dual channel inputs, Low/High for complementary dual channel inputs) or power cycle the main module.

*2 After one of the dual channel inputs is set to ON and another is OFF, when the discrepancy time passes, “Extension module n: Discrepancy time error at dual channel input Ii” should occur. This discrepancy can be cleared when both inputs turn OFF (the left side of Figure 4). However both inputs turn ON during the discrepancy, it is not cleared and this error should occur (the right side of Figure 4).
