Notice of Corrections to Mitsubishi General-Purpose AC Servo MR-J3-B Safety SERVO AMPLIFIER INSTRUCTION MANUAL Connection Diagram

1. Target Manual

Manual name	No Rev.	Relevant pages
MR-J3-B Safety SERVO AMPLIFIER INSTRUCTION MANUAL	SH030084-C	15-9, 15-10

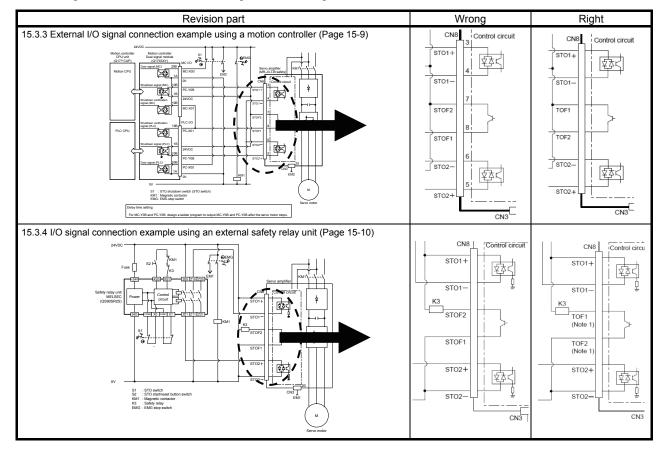
Thank you for your continued patronage of the Mitsubishi general-purpose AC servo. Some errors were found in the MR-J3-B Safety SERVO AMPLIFIER INSTRUCTION MANUAL, in which the connection diagrams are explained. The servo amplifier could be damaged if the connection is mistaken. Please check the following details, and pay special attention to the connections.

The signal name in connection diagrams is changed to as follows. STOF2 \rightarrow TOF1, STOF1 \rightarrow TOF2

Technical material in which the corresponding sections have been corrected has been published as shown below.

Manual name	No Rev.	Revision timing
MR-J3-B Safety SERVO AMPLIFIER INSTRUCTION MANUAL	SH030084-D	Sep. 2012
